AFAPL-TR-79-2020

**BUILD 1 OF AN ACCELERATED MISSION TEST  
OF A TF41 WITH BLOCK 76 HARDWARE**

TECHNICAL REPORT AFAPL-TR-79-2020  
Final Report for Period 18 October 1977 - 13 January 1978

AIR FORCE AERO PROPULSION LABORATORY  
AIR FORCE WRIGHT AERONAUTICAL LABORATORIES  
AIR FORCE SYSTEMS COMMAND  
WRIGHT-PATTERSON AIR FORCE BASE, OHIO 45433

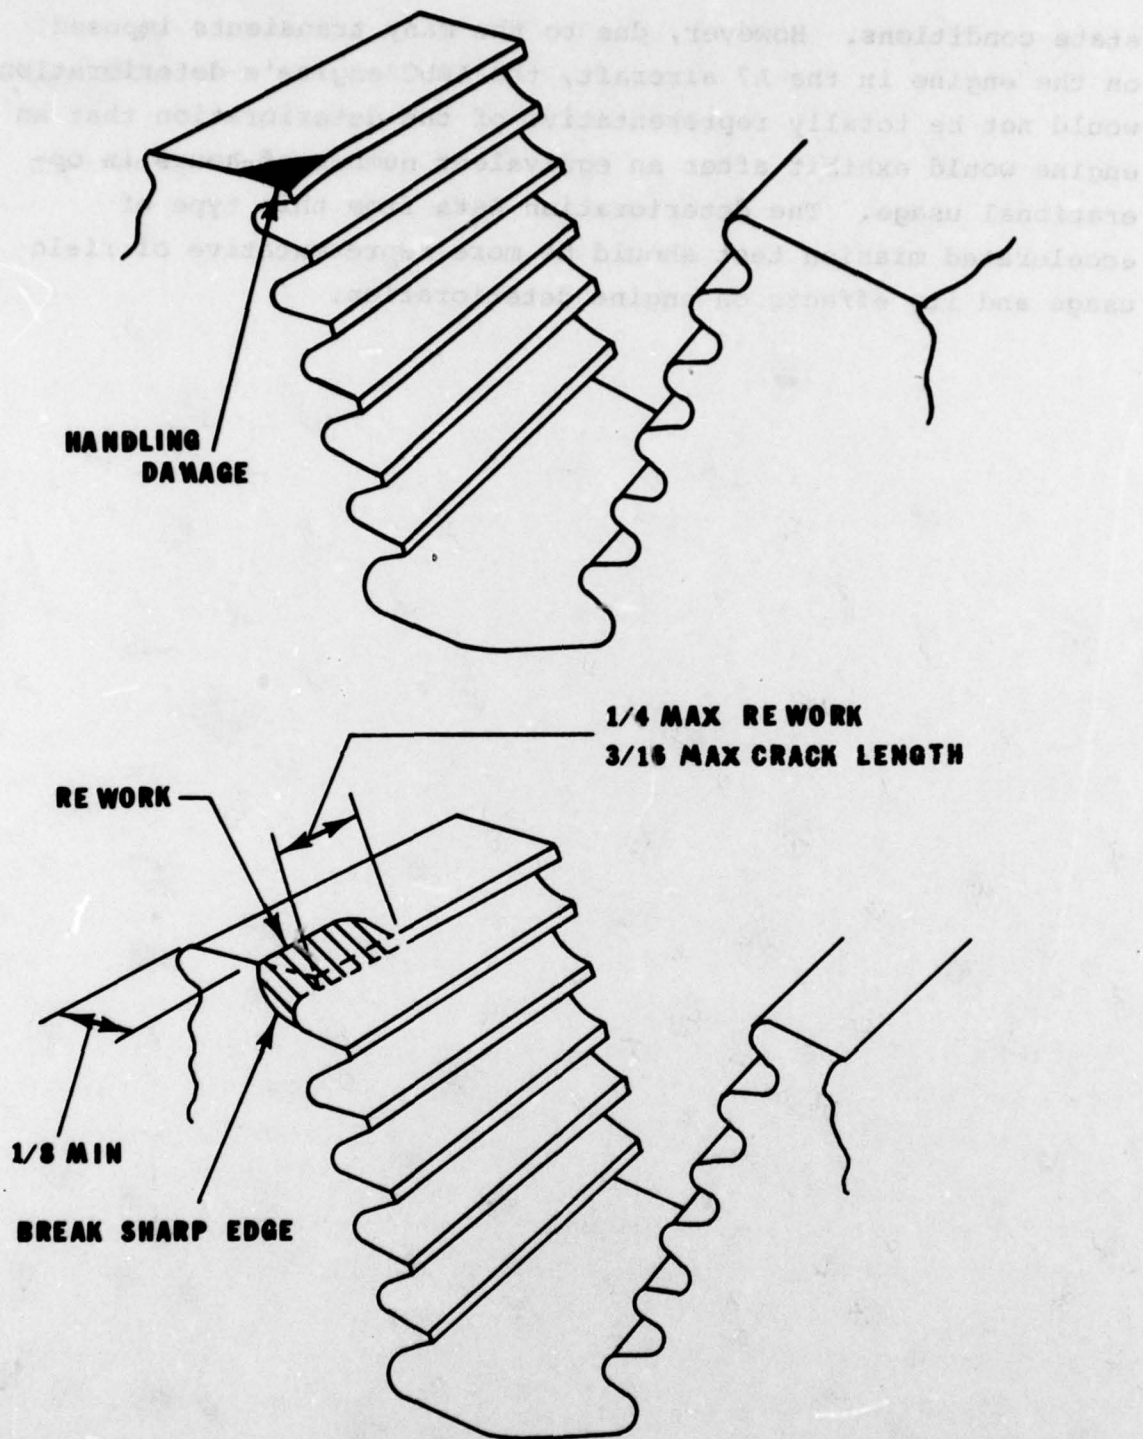
Figure 1 HPT-2 Wheel Handling Damage and Proposed Rework

Second stage high pressure turbine wheels with crack indications on the face and extending along the root radius were first reported in mid-1976. Exhibits were returned to Allison who determined the cause was handling damage during overhaul. A recent review at the Navy's Jacksonville overhaul facility showed that 2/3 of the HPT-2 wheels have this problem. The Air Force is experiencing similar

handling damage, although apparently to a lesser extent. A recent TF41 Management Review Group Meeting highlighted this handling damage as a major TF41 problem area.

Allison has proposed a short term solution which consists of a blending rework of the damaged teeth (Figure 1). (The long term solution includes major structural changes, which if accepted will not be ready for several years). A reworked turbine wheel has been run through 52 hours of AMT testing and 48 hours of resonance testing for the initial clearance of this rework procedure. The initial release of this rework allows a maximum of 250 hours service life. In keeping with the 1975 TF41 Executive Review Group's mandate that "there must be very careful testing and verification of the adequacy of repair procedures for the critical hot section of the engine", (Ref. 1) this rework procedure will be verified in this 263 hour AMT test to extend the rework time limit from 250 hours to 450 hours.

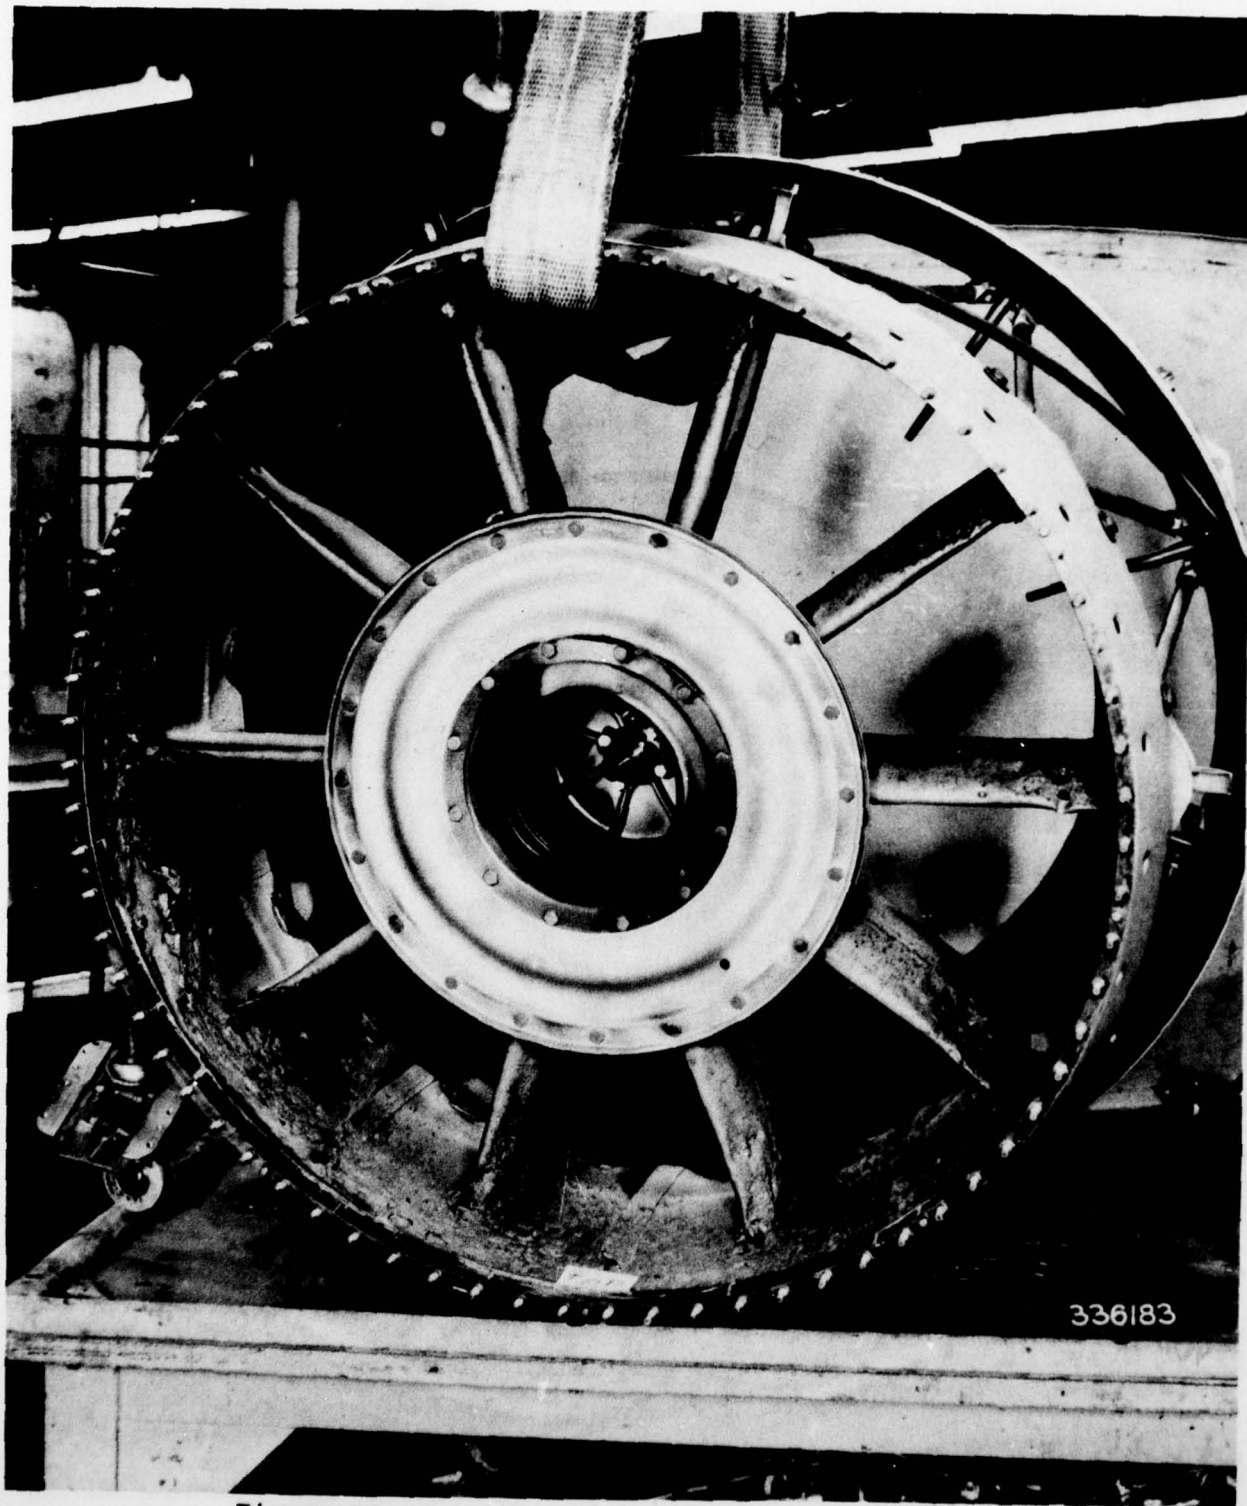
Figure 38 L.P. Turbine Bearing Support Fairing

- Crack in L.P. Turbine Bearing Support Fairing - Two cracks of approximately 2 inches each in length were discovered on the struts at approximately the 2 o'clock and 7 o'clock positions on the fairing during the 100 hour phase inspection. The cracks were repaired by stop drilling and welding.

Engine inspections were performed at 50 and 100 AMT hours according to the instructions in section 7 of Allison publication No. 1F2, TF41-A-1 Engine Operation and Service. The only discrepancies encountered were the cracks in the L.P. turbine bearing support fairing which were discovered at 100 hours. The cracks were repaired by stop drilling and welding.

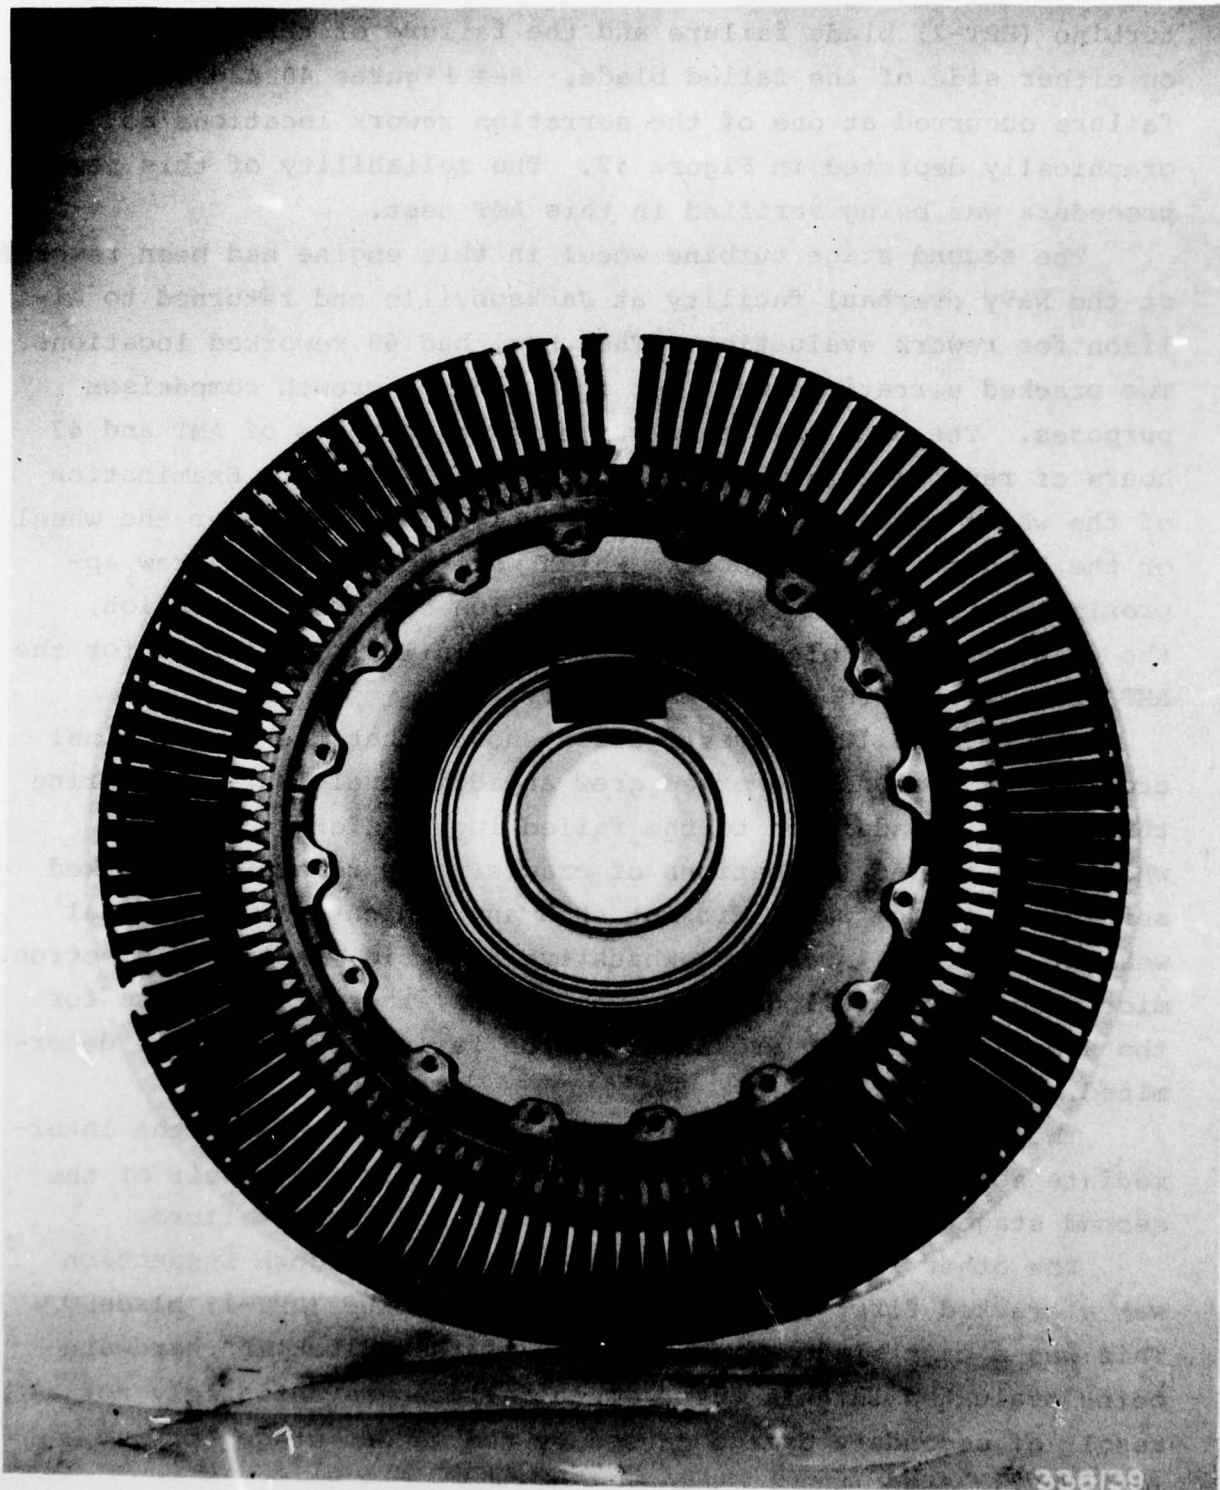
Figure 39 Second Stage H.P. Turbine

The engine failure was due to a second stage high pressure turbine (HPT-2) blade failure and the failure of the wheel lugs on either side of the failed blade. See Figures 40 and 41. The failure occurred at one of the serration rework locations as graphically depicted in Figure 42. The reliability of this rework procedure was being verified in this AMT test.
